CASPER conduction of a test program of realistic situations: misuse, postural change, inappropriate use

Introduction

The current study presents the operative approach followed by CASPER partner and the results of a detailed test program based on the evaluation of realistic and possible situation about typical misuse: wrong fixation of the CRS, wrong child restraining, inappropriate use, child postural. The new defined test program is complementary to the one of test results already available (CHILD project).

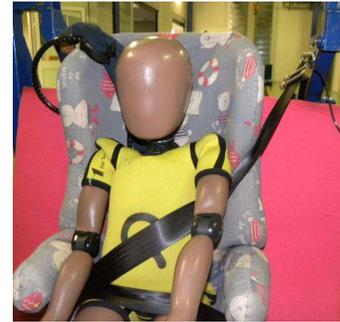
Figure 1.3: harness under the arms

The figure 1.3 shows a very common misuse configuration about group 2/3 (7% of the observed field data), using a very

popular CRS. This misuse was also detected in a real accident, reconstructed in Casper project (CCN 2032). The test was performed on the regulation bench using: pulse and the CRS similar to the ones used in the reconstruction, abdominal sensors in the Q3. Even if the position of the diagonal belt seems different between the reconstructed accident and the ECE bench (position of the belt anchorage points), the forces applied to the dummy in the misuse configuration seem to be realistic with regard to the child injuries in the real accident: head contusion, liver rupture, pancreas rupture, fracture of the 5th rib left, with pneumothorax.

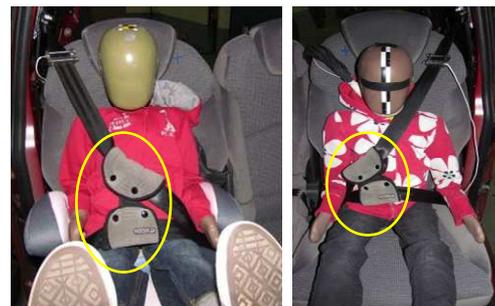
Figure 1.4: Seatbelt routes with “add-on” Q3 (on the left) and Q6 (on the right)

In the figure 1.4 a commercial seatbelt adjuster was used applied to Q3 and to Q6 dummy. The seatbelt adjuster is a device created to help in the positioning of the upper part of the seatbelt. It should avoid interaction between the neck and the seatbelt and reduce the risk of neck wounds. Generally the results for both show a better behavior with this adjuster respect to the standard configuration.

Contrary to this, the film analysis shows, that the diagonal part of the seatbelt is highly loading the lower part of the chest and the upper part of the abdomen from the very beginning of the test. The belt remains in that position until the end. These tests and some accidentology feedback show, that this device has some very dangerous side effects, because it amplifies the risk of submarining through a poor positioning of the belt on the abdomen even if used in combination with an approved CRS. Dummy readings are not able to translate this additional risk except when the abdominal sensor is used.

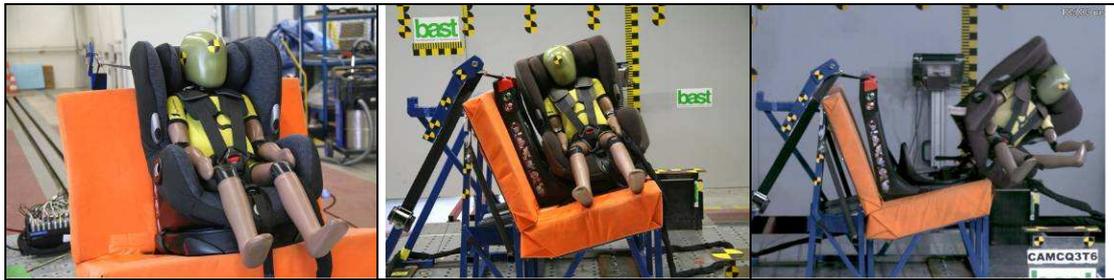
Figure 2.2: Configuration with seat shell turned 90°: Reference condition; misuse; during the test

Relevant are the effect linked to the configuration with the “Seat shell turned 90°” (fig. 2.2). The used CRS shell can be turned 90° to allow an easy attachment of the children. The shell has to be turned back afterwards.

During this test the CRS was destroyed; the CRS shell separated from the base. The use of a CRS with a rotated shell has shown a complete reduction of the efficiency of the CRS leading to the ejection of the child dummy and the shell from the test bench.

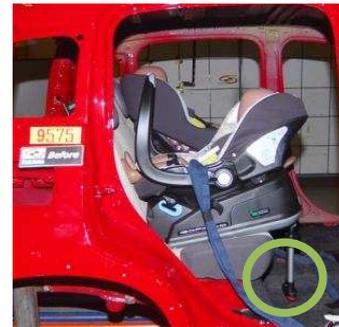
Figure 3.2: support leg too short

When the support leg is too short (the misuse condition is evidenced by a red indicator on the support leg) as shown in figure 3.2 the absence of the anti-rotation device produced a rotation with failure of the base and unlocking of the carrycot. The base of the CRS (ISOFIX base) rotates until the support leg is in contact with the floor of the vehicle and then breaks it. Simultaneously the carrycot rotates and unlocks from CRS base falling down towards the front passenger area. This misuse produces a high risk of child injuries due to the risk of impact against a rigid part of the car.

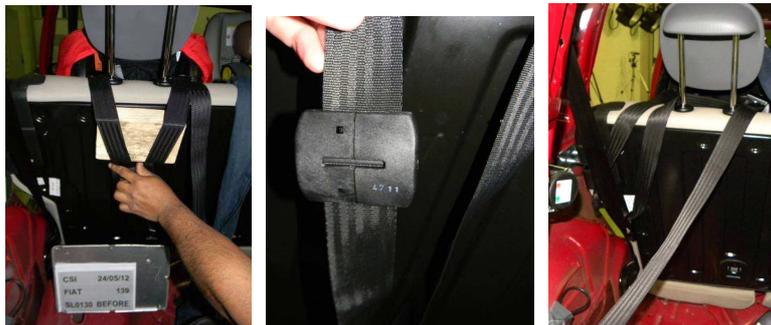
Figure 3.3: Illustrations of introducing slack in top tether, indicator not green and no top tether

In the figure 3.3 two misuse configurations using a Forward Facing G1 CRS with top tether as anti-rotation device are shown. In the first test some slack is introduced in the top tether (indicator is not green) and in the second one the top tether is simply not used at all.

The effects of such misuse are very depending on amount of slack in the top tether and could lead to serious consequence in the non use of top tether, for the absence of anti-rotation device. The risk of a contact between the child and the front passenger seat backrest becomes relevant.

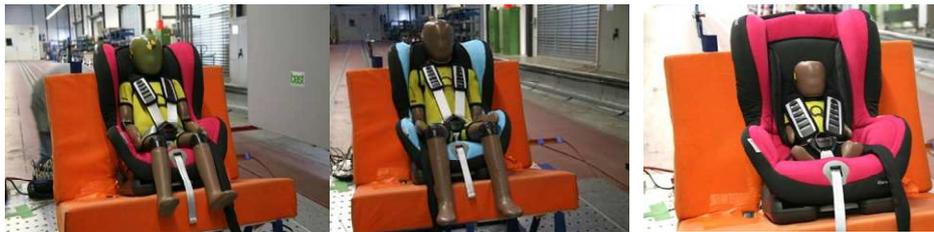
Figure 4.2: Test set up with an ISOFIX CRS and Q3 (reference), Q6 (too heavy) and Q0 (too small)

In figure 4.2 is shown the misuse configuration about the wrong child size, for a G1 CRS. Neither the Q6 nor the Q0 can be correctly restrained. For the Q6 the upmost shoulder strap position is too low, the harness is difficult to close and the dummy’s head is fare above the CRS. For the Q0 the shoulder strap padding does not allow to tighten the harness.

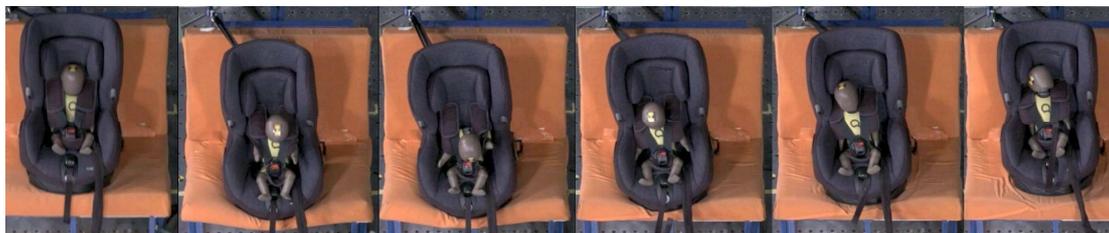
Figure 4.3: Film Sequences Q0 in a Group I CRS

Even though the measurements are not clear, it can be seen in film and photo analysis that the Q0 is not well restrained (Figure 4.3). It seems to be a dummy artefact that the Q0 sticks within the harness system. A child of this age/weight could escape from the harness during the impact.

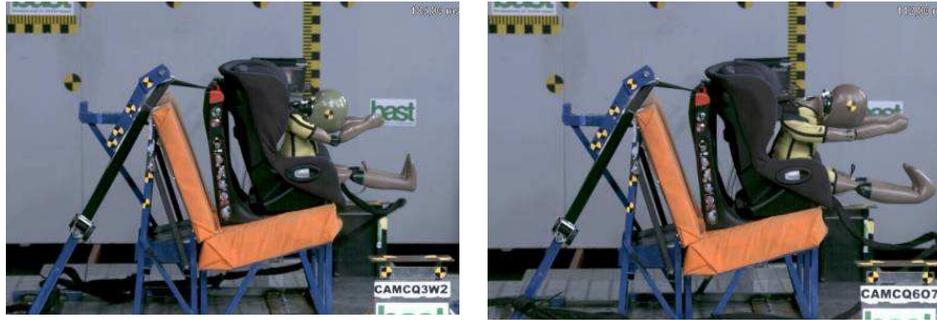
Figure 4.4: Comparison of the head excursion Q3 reference test – Q6 (belted CRS)

The use of a Q6 dummy in the Group 1 CRS chosen, did not affect the CRS integrity. The dummy readings show lower values for the Q6 in comparison to the Q3 in the reference test. For the Q6, the film analysis shows that the head excursion increases a lot, so that the danger of head contact in vehicle crashes increases (Figure 4.4).

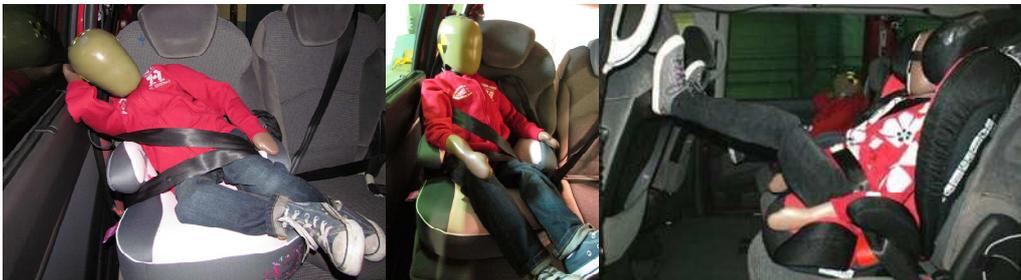
Figure 5.2: Posture position in combination with typical misuse – using a Q6 dummy

In the figure 5.2 several posture position in combination with typical and common misuse are shown using a Q6 dummy:

- Bending to the window and Seatbelt under the arm (on the left)
- Body Twisted and Seatbelt under the arm (on the centre)
- Feet on front seat (on the right)

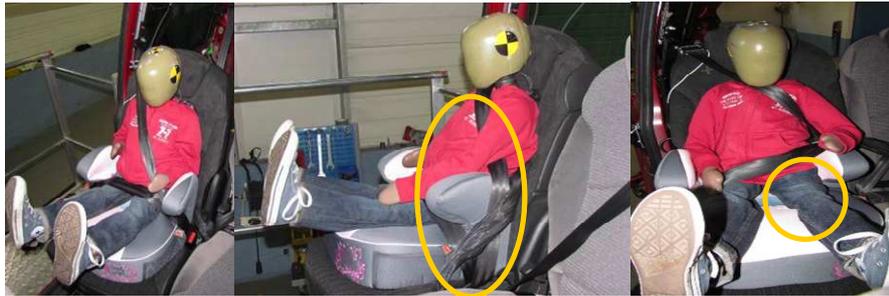
Figure 5.5: Different seat belt route.

The Q3 dummy, in association with a CRS Group 2/3 without backrest several test are performed with aim to analyze the effect of different seatbelt route. In the figure 5.3 two different ways to install a child seat have been compared with a clearly defined misuse (wrong routing belt):

- Q3 in standard position without misuse (on the left)
- Q3 installed with an alternative child seat installation (on the centre)
- Q3 installed in a CRS with a wrong routing of the belt (on the right)
